Subject: November 6, 2015 Compliance Evaluation Inspection

**CWA COMPLIANCE EVALUATION INSPECTION REPORT
U.S. ENVIRONMENTAL PROTECTION AGENCY, REGION 5**

Compliance Evaluation Inspection

Ex. 6 (Personal Privacy) Pork - Breese Site Location
Photolog and Walkthrough Documentation
EPA Inspection November 6, 2015

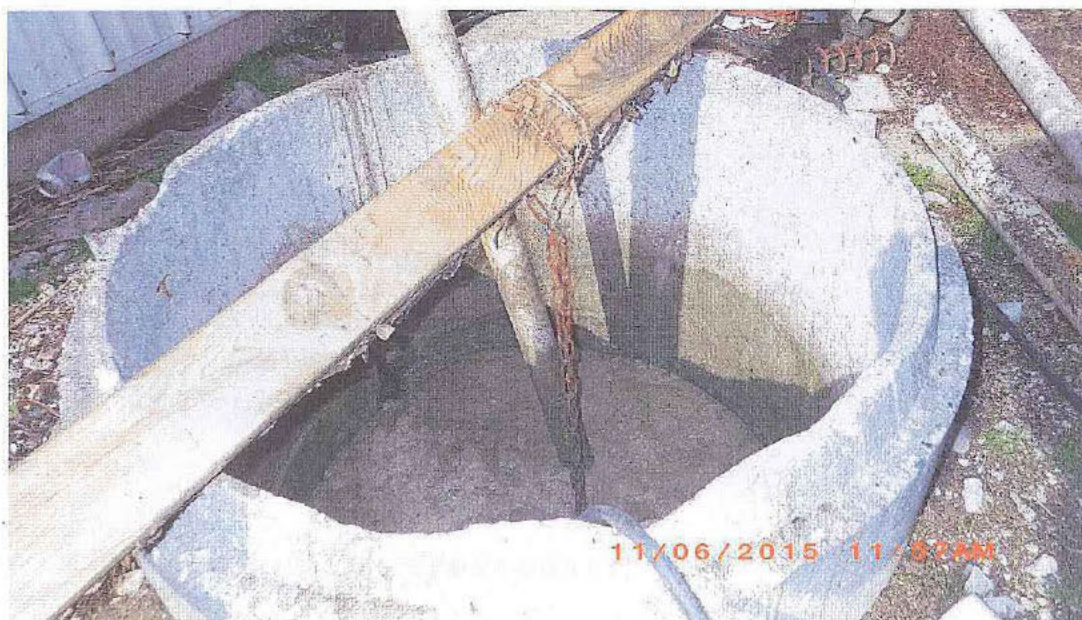
1: RIMG0019

Description: Looking down into the cleanout pipe east of Barn #2. Manure level indicates that the manure in the pit below Barn #2 is about half full. A pump in this cleanout pumps the manure from Barn #2 through Barn #3 and directly to the Complex Lagoon.

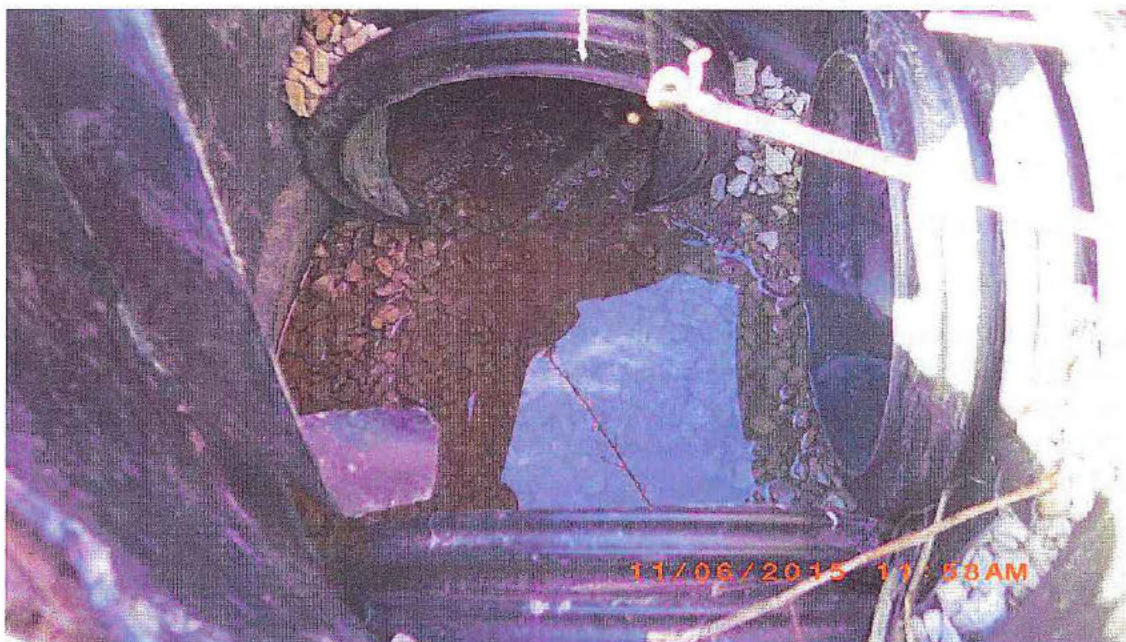
2: RIMG0020

Description: Storm water pipes in storm water manhole.

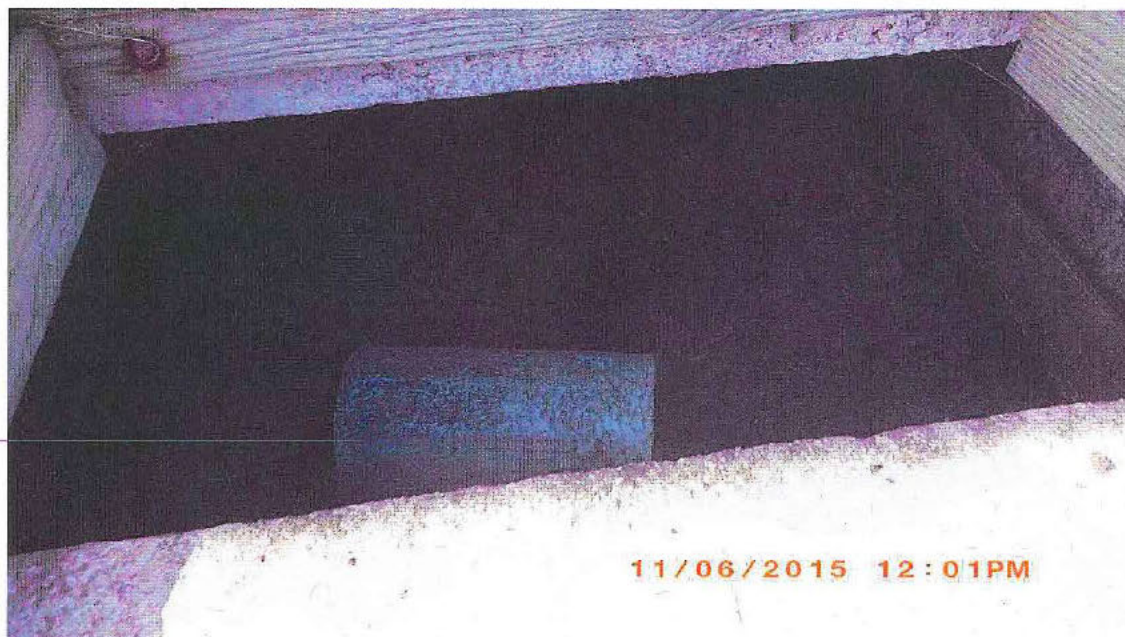
3: RIMG0021

Description: There is still manure in the pit below Barn #4 even though this barn is not used to confine hogs anymore.

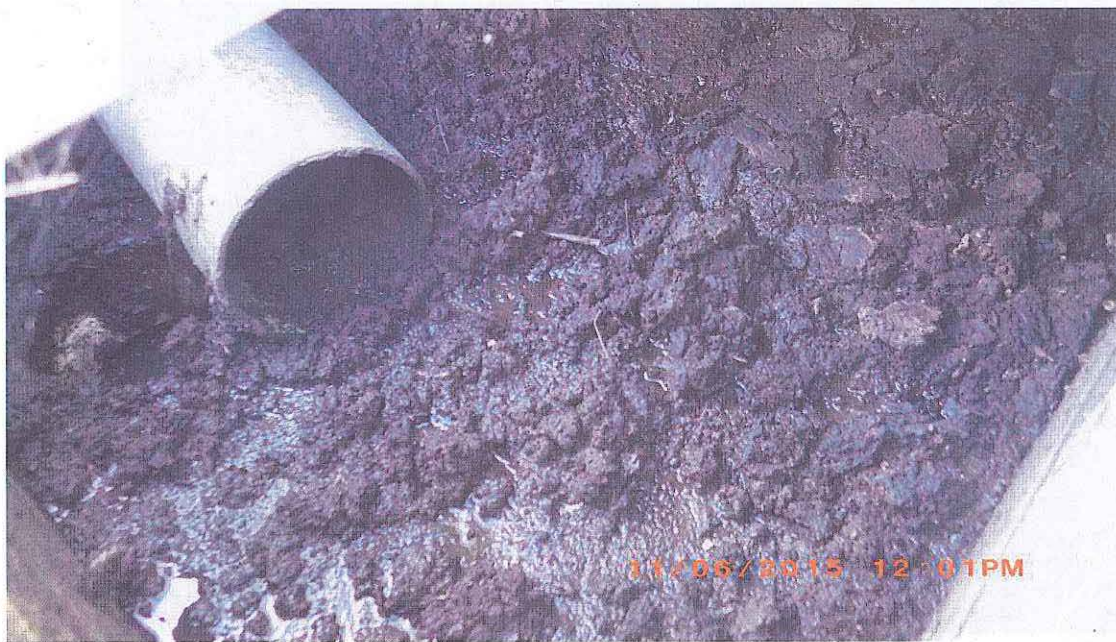
4: RIMG0022

Description: Manure pipe in eastmost cleanout structure south of Barn #3. Manure is just up to pipe. Manure piping takes a 90 degree turn to the north here.

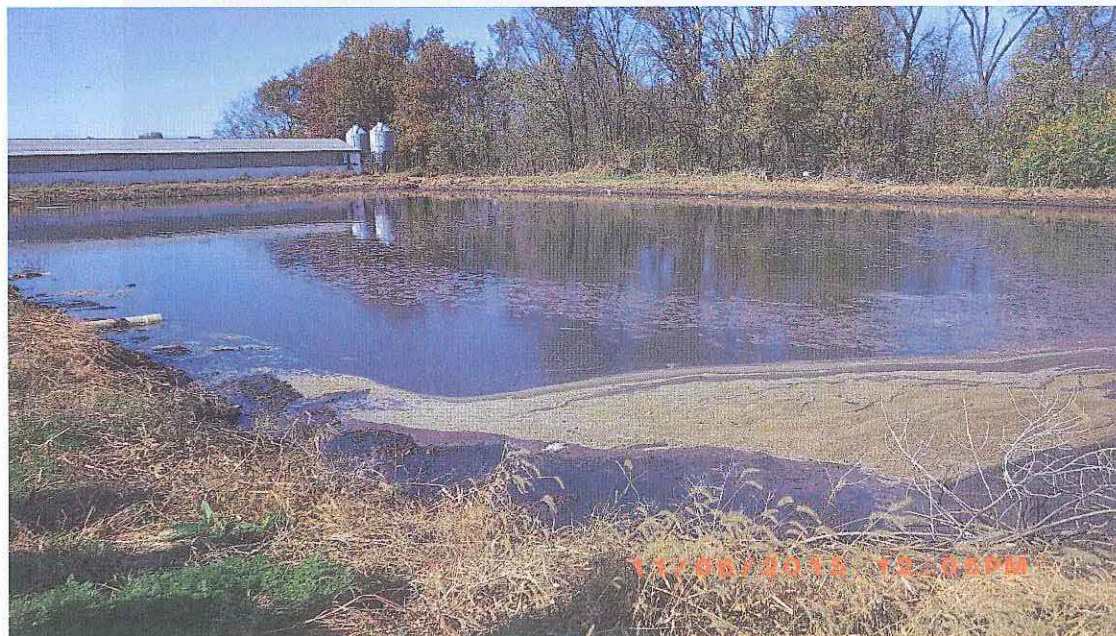
5: RIMG0023

Description: Complex Lagoon has approximately 3' of freeboard.

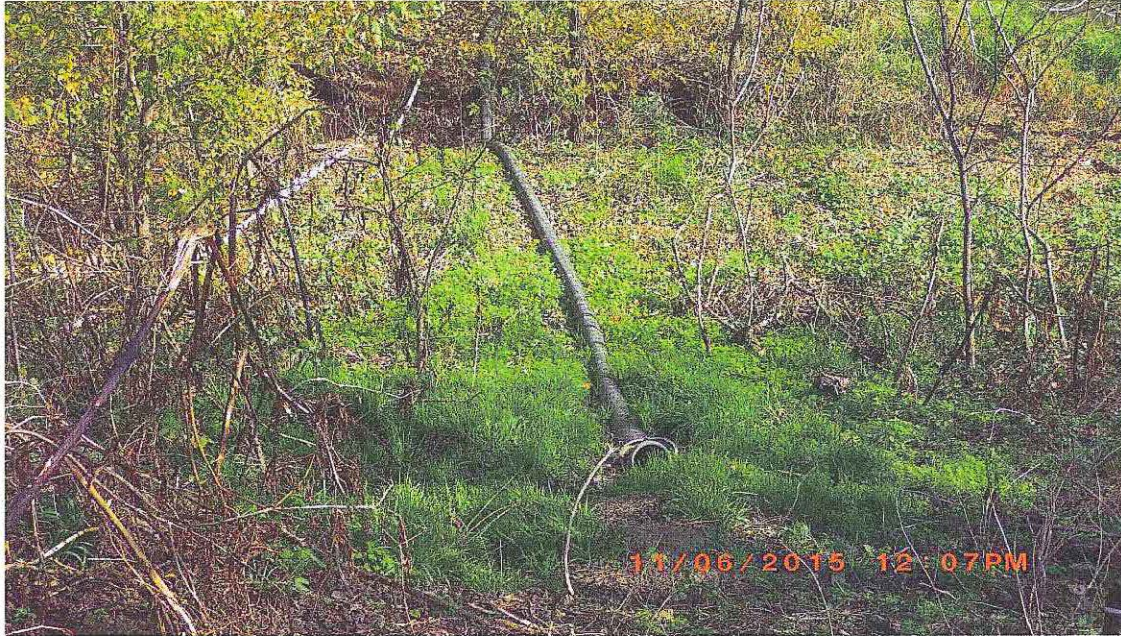
6: RIMG0024

Description: Piping used to transfer manure from 5-6 Lagoon to Complex Lagoon.

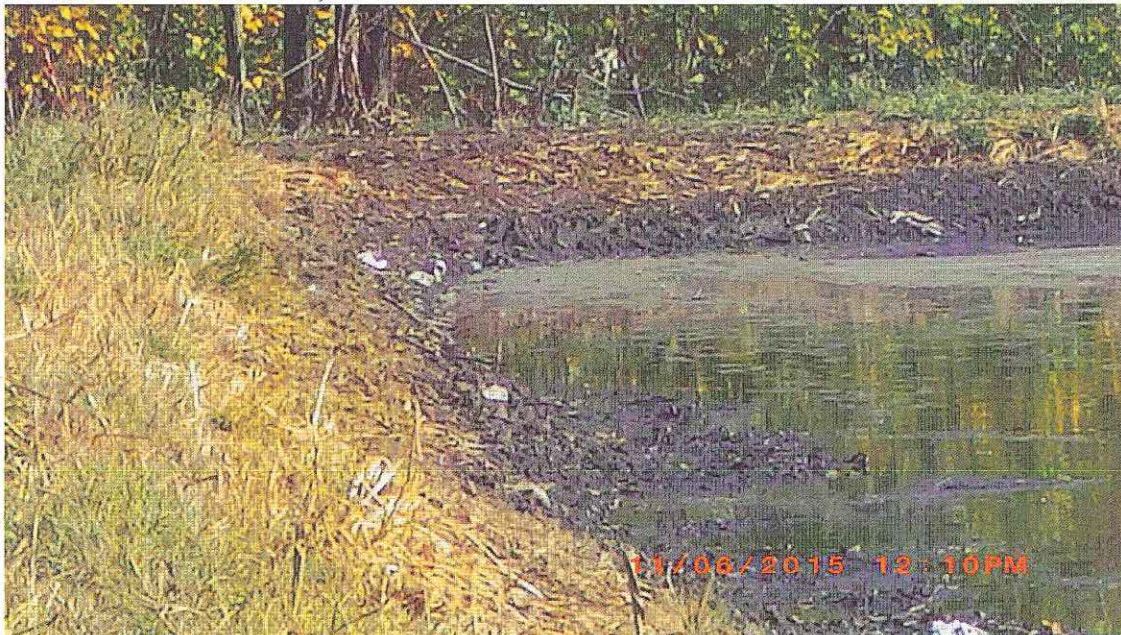
7: RIMG0025

Description: Northwest corner of Complex Lagoon where pipe from Barn #1 discharges to lagoon.

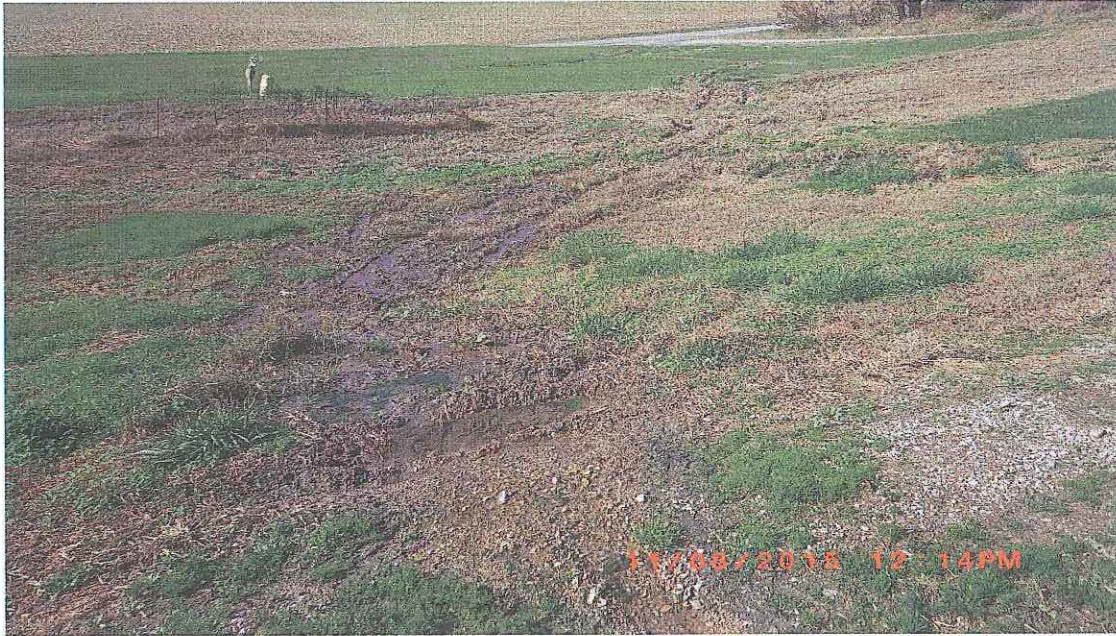
8: RIMG0026

Description: Broken water line in front yard west of Barn #1.

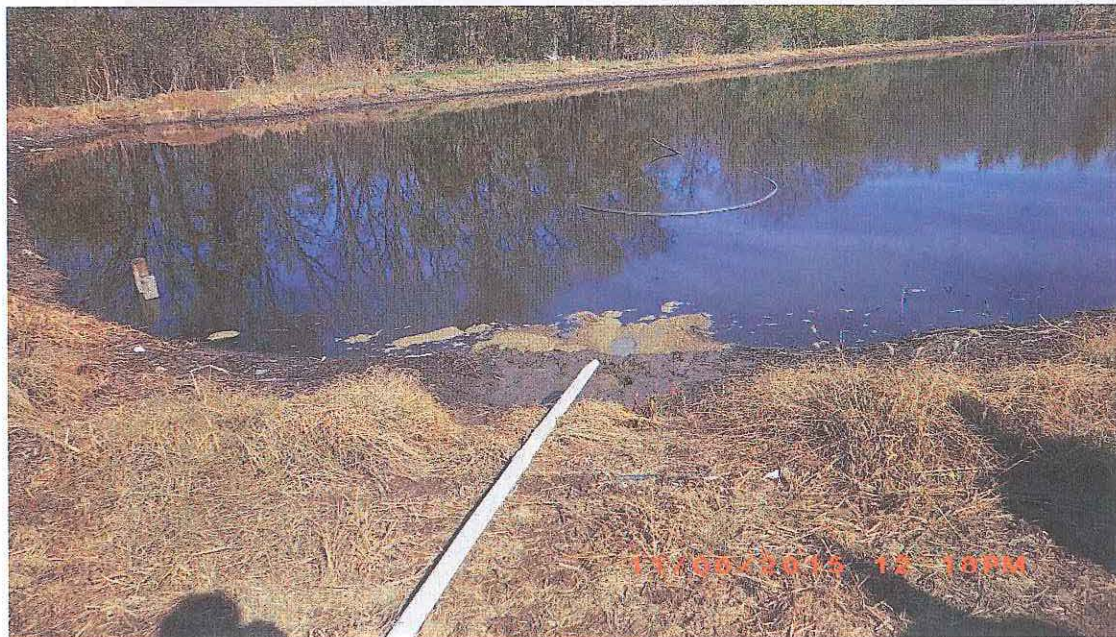
9: RIMG0027

Description: Pipe from Barn #2 discharges to the Complex Lagoon after being piped through Barn #3.

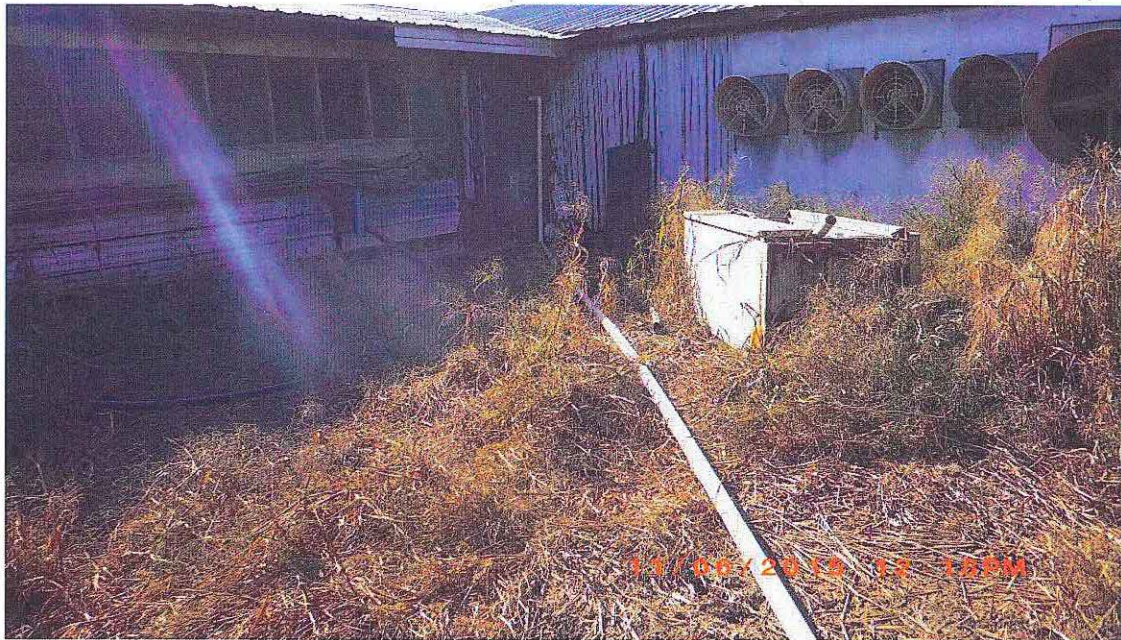
10: RIMG0028

Description: Piping from pit under Barn #2 comes out on north side of Barn #3.

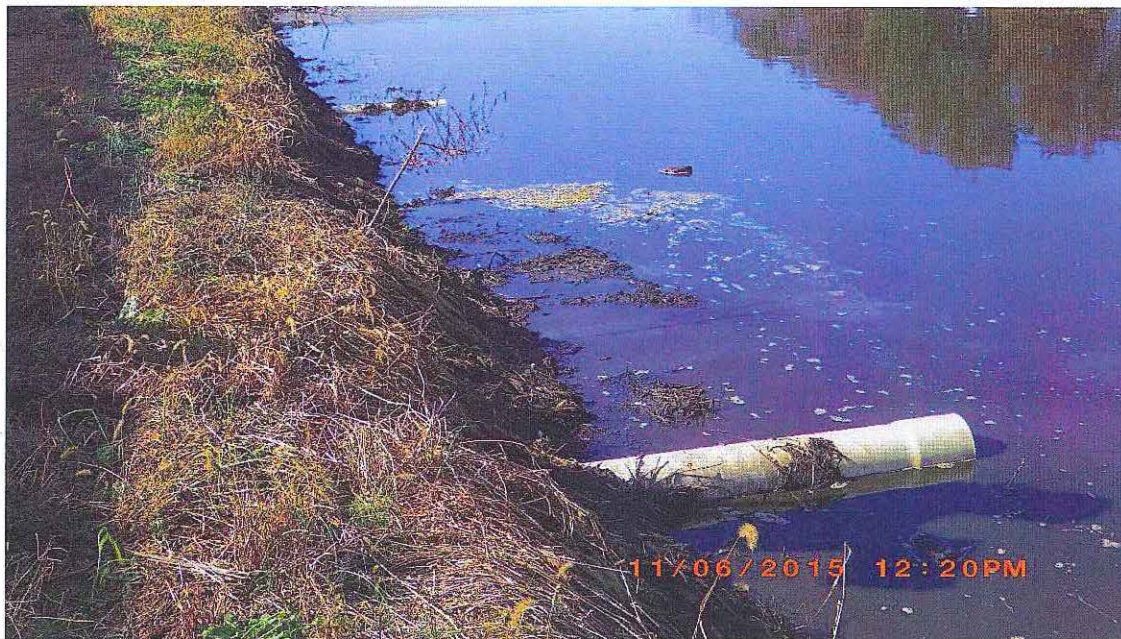
11: RIMG0029

Description: Pipe from north side of Barn #3 discharges to the Complex Lagoon.

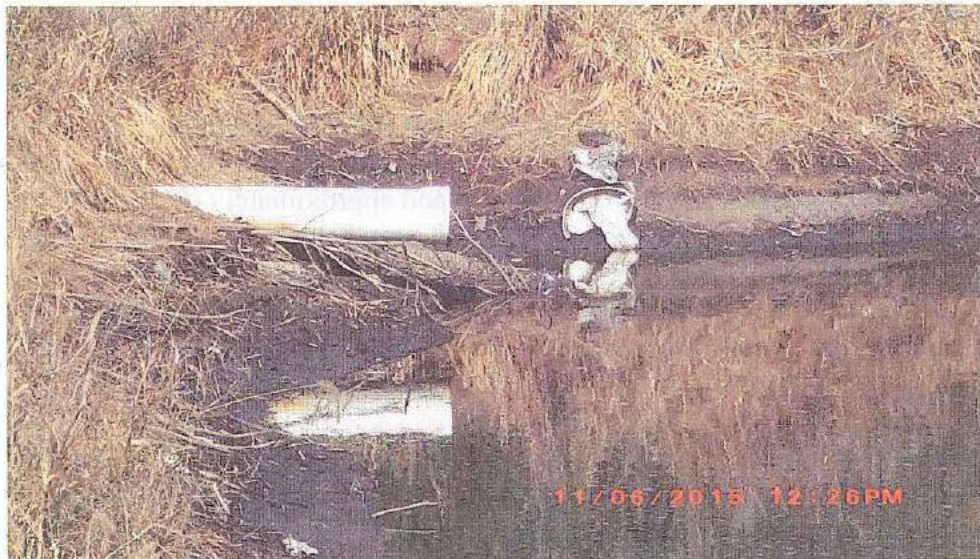
12: RIMG0030

Description: Manure pipe for Barn #5 goes directly to the 5-6 Lagoon at its northwest corner.

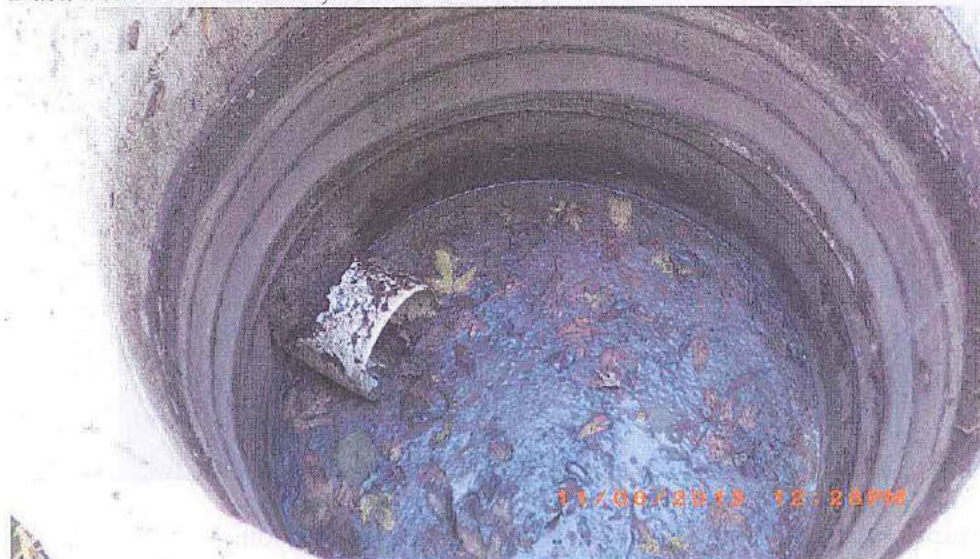
13: RIMG0031

Description: Manhole for manure pipe from Barn #5.

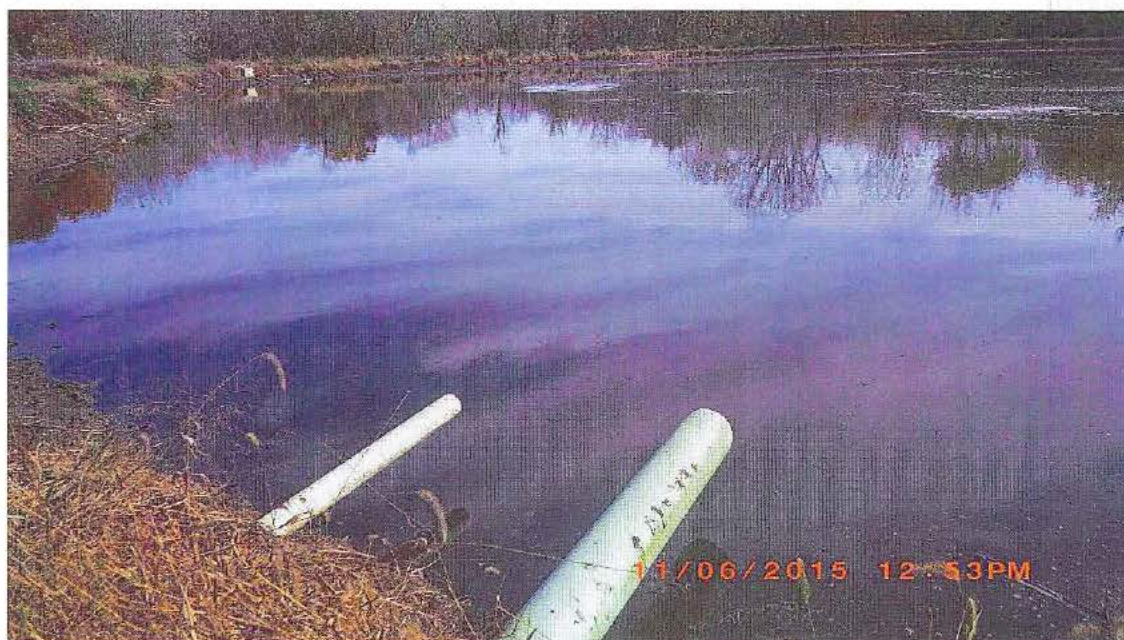
14: RIMG0032

Description: Manure pipes for Barn #8 and Barn #7 to the West North Lagoon.

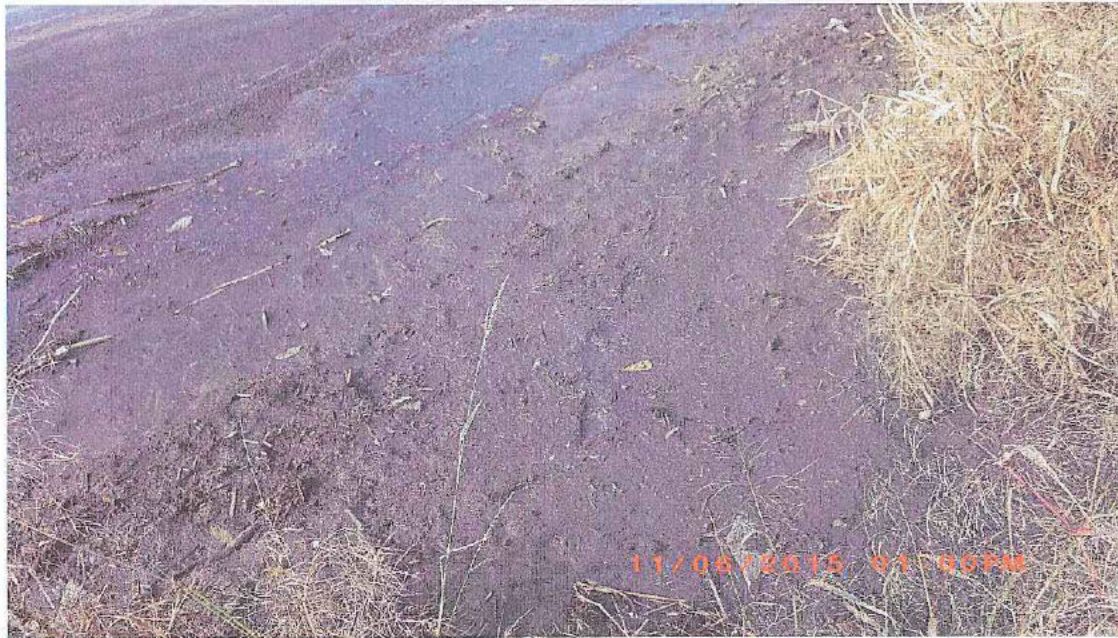
15: RIMG0033

Description: Cut out area of lagoon berm where pump can be put in to agitate and remove waste.

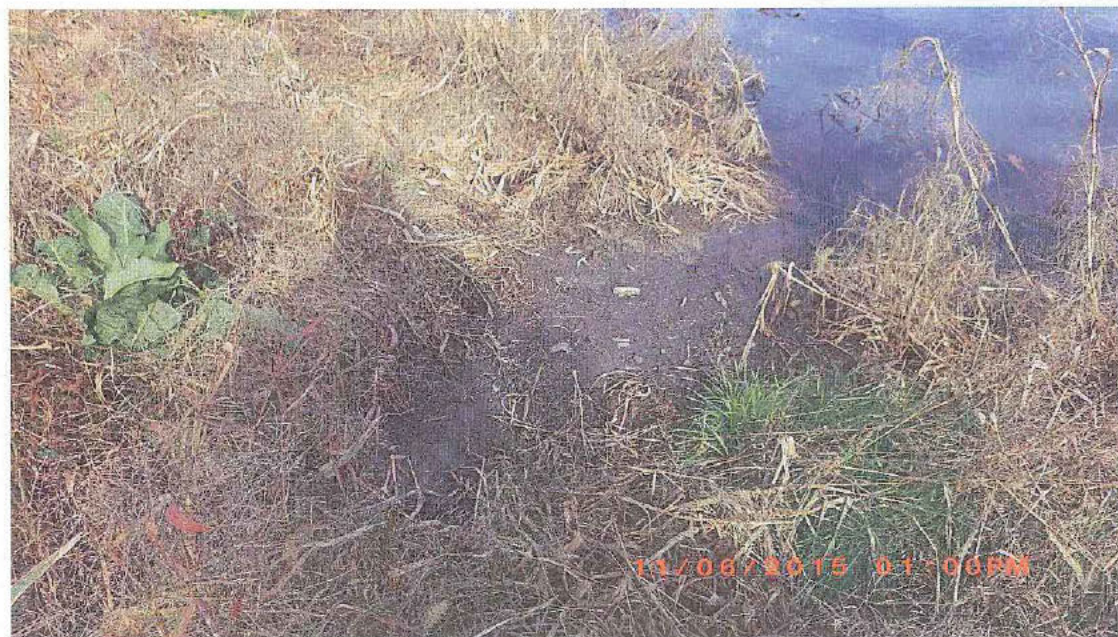
16: RIMG0034

Description: Cut out area of lagoon where pump can be put in.

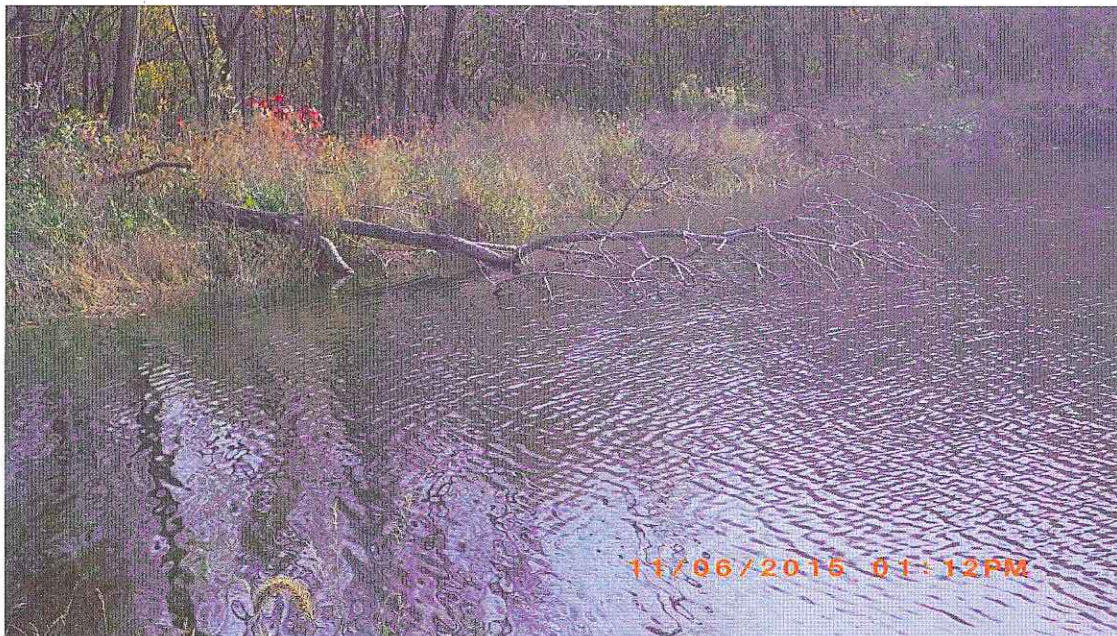
17: RIMG0035

1. There were tree trunks laying on the berm and in the East North Lagoon.
2. There was only approximately 6" of freeboard in the East North Lagoon.

Description: South side of East North Lagoon. Trees cut were allowed to fall into lagoon after being cut.

Ex. 6 (Personal Privacy) intended to have the berm reshaped and planned to remove these trees at that time.

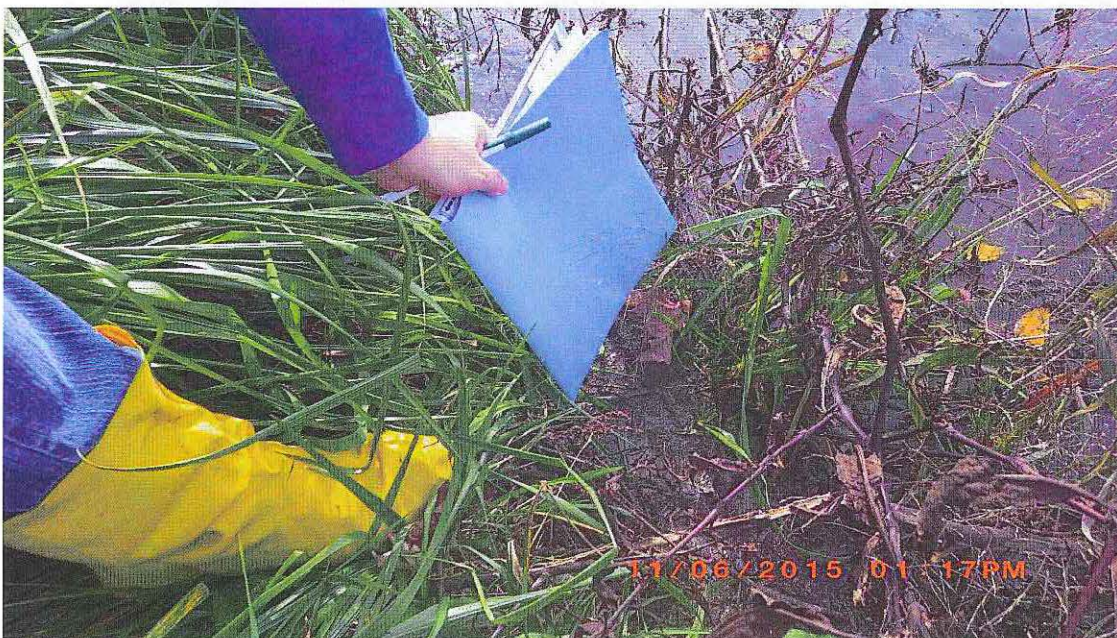
18: RIMG0036

Description: Level of freeboard on east side of East North Lagoon is only 6".

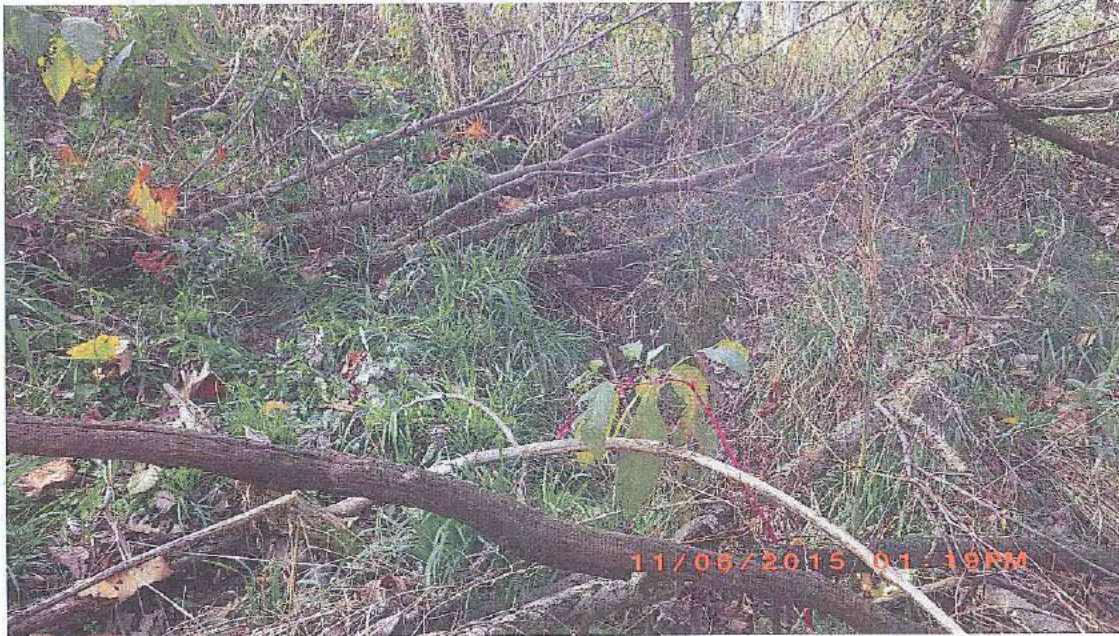
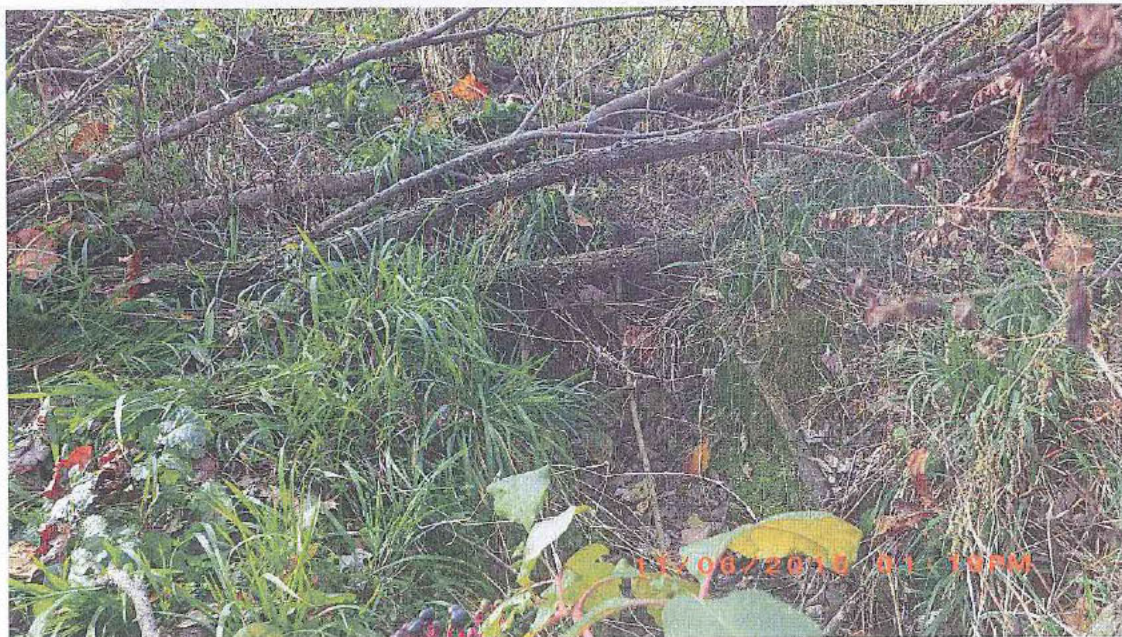
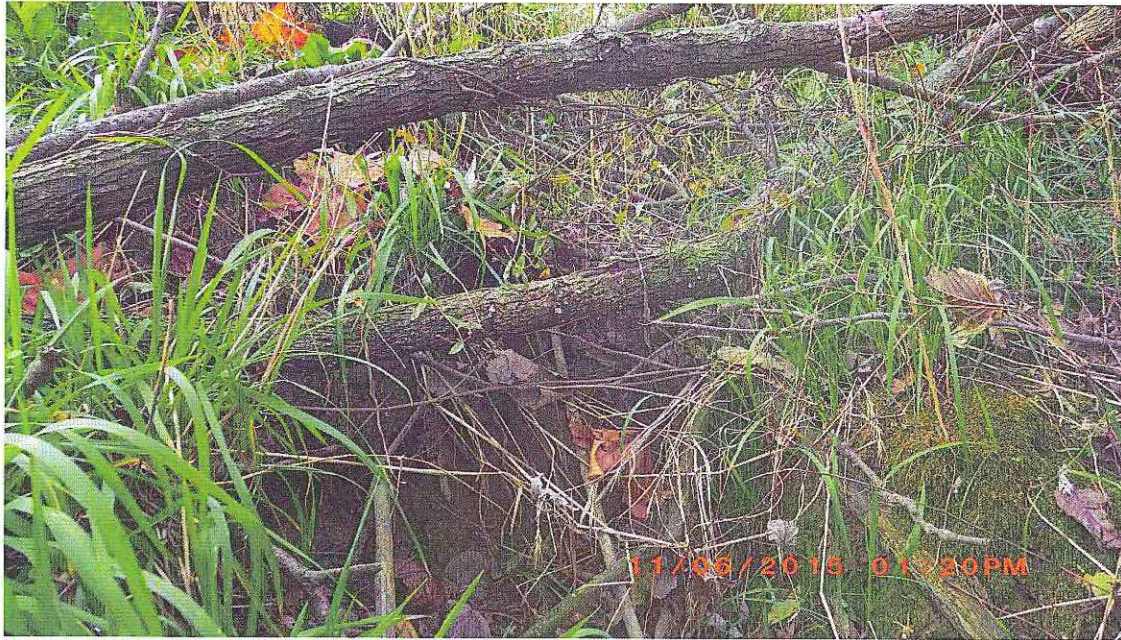
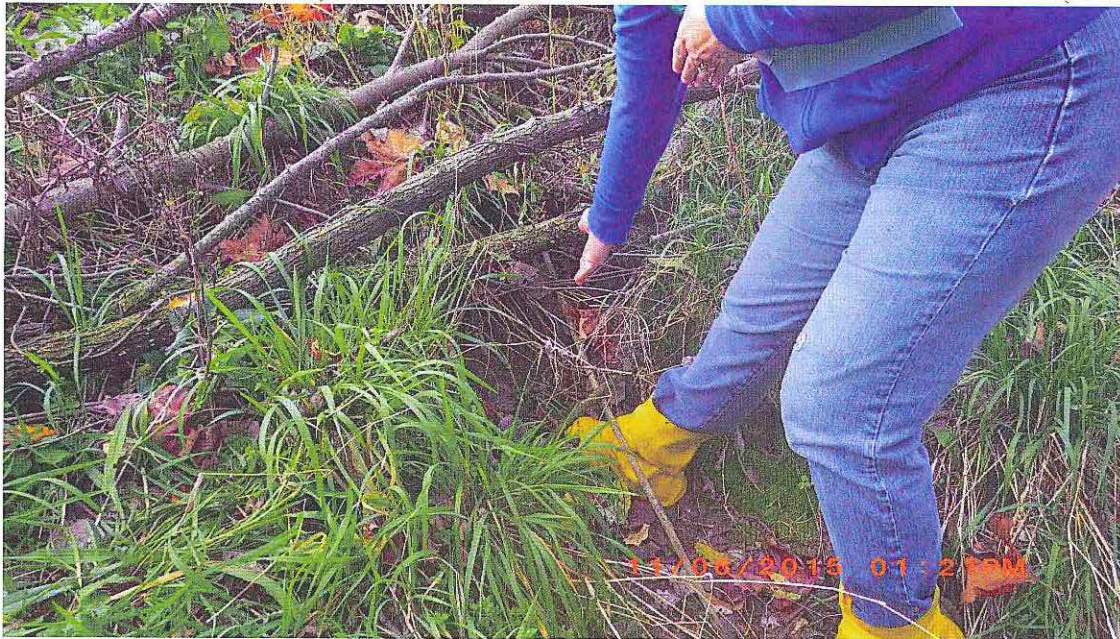
1. There was evidence of possible discharges of wastewater from the east side of the East North Lagoon. Channelization on the berm indicated that there had been concentrated flow down the side of the berm.

Description: Erosion channel on the east side of the East North Lagoon.

Description: Erosion channel on the east side of the East North Lagoon. Channel is under the brush and branches.

As you discussed with Joan Rogers in a phone conversation following this inspection, you agreed to provide photo documentation of the reshaping of the east berm of the East North Lagoon by December 31, 2015. If you are not able to provide this information by that time, please contact Joan Rogers of my staff at (312) 886-2785.
